# **NATIONAL TRANSPORTATION SAFETY BOARD**

## **HAZARDOUS MATERIALS ACCIDENT REPORT**

**HAZARDOUS MATERIALS RELEASE  
FOLLOWING THE DERAILMENT OF  
BALTIMORE AND OHIO RAILROAD COMPANY  
TRAIN NO. SLFR  
MIAMISBURG, OHIO  
JULY 8, 1986**

**NTSB/HZM-87/01**

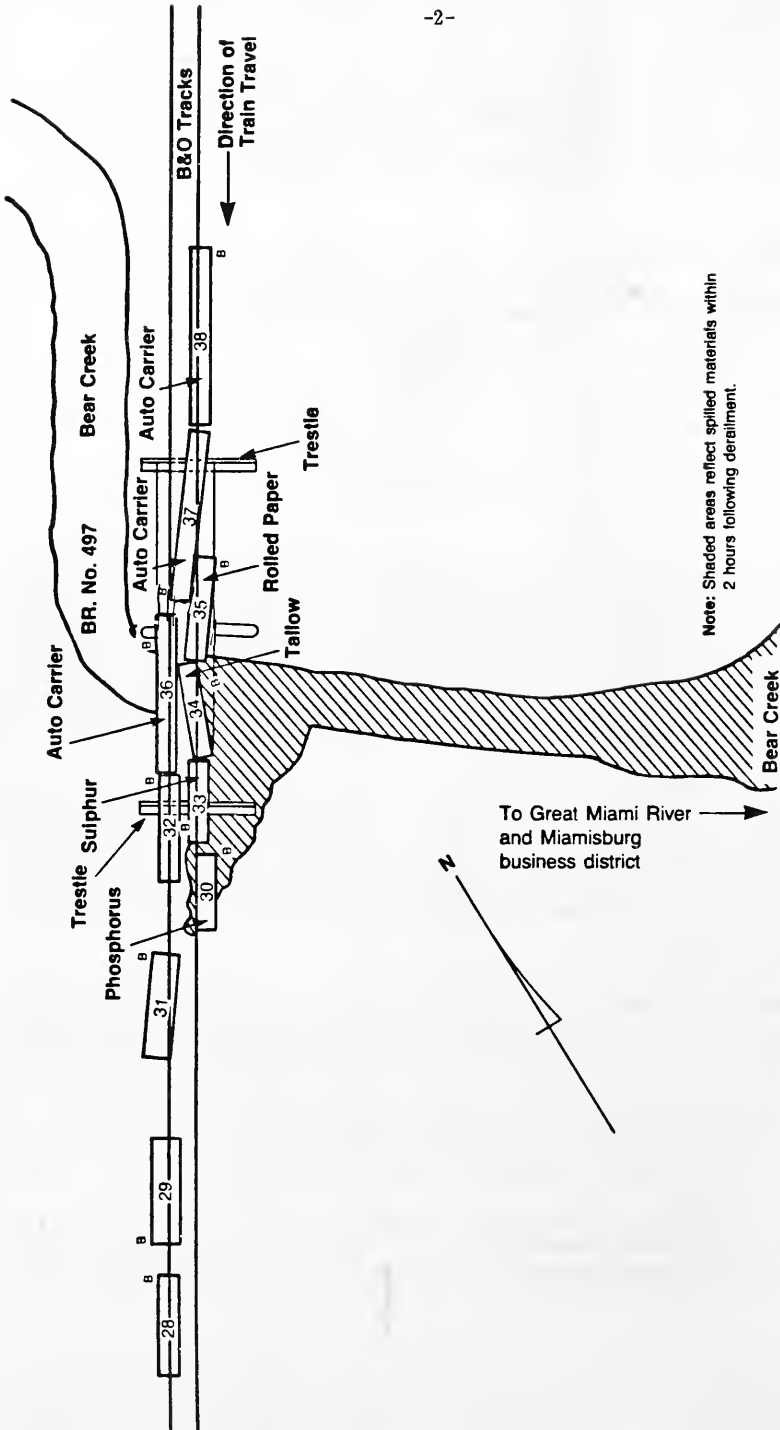
Figure 1.—Derailement site.

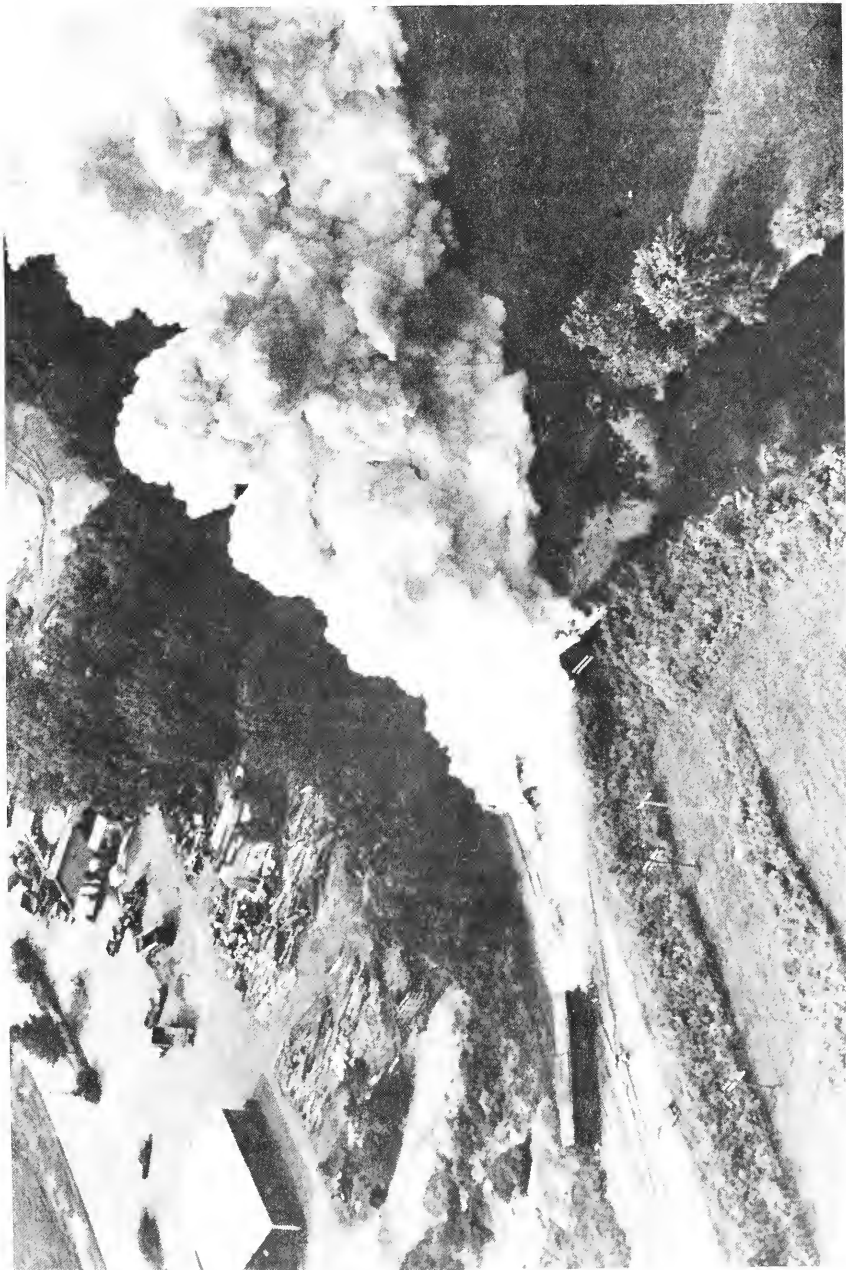
Figure 2.—Cloud viewed from the city east of the accident site.
